CHARACTERIZATION OF HIGH POWER GAS SWITCH FAILURE MECHANISMS

E. E. NOLTING

Naval Surface Weapons Center
White Oak, Silver Spring, Maryland 20910

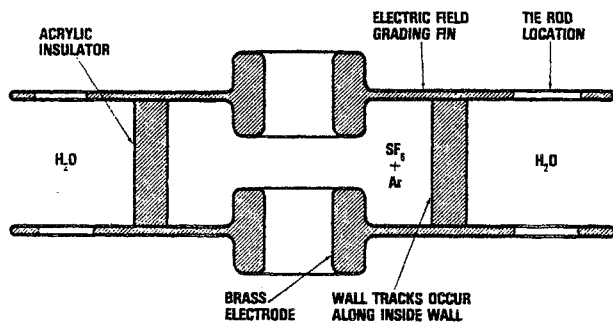
Inspection of the insulator walls showed that faint tracks bridged the length of some of the insulators. Figure 1 indicates location of wall tracks. It was evident that little energy was actually transferred along the insulator wall because of the lack of damage found on either the insulator or the adjacent grading fin. Apparently current passing along the inside wall acts as trigger mechanism for the associated electrodes. Initiation of the main gap closure may occur because of imbalance of the electric field at electrodes due to the surface tracks causing asymmetric field distortion. Another possible mechanism is the generation of ultraviolet radiation at the insulator wall that illuminates the electrode.

Fig. 1. Cross-sectional view of single section of multistage gas switch.

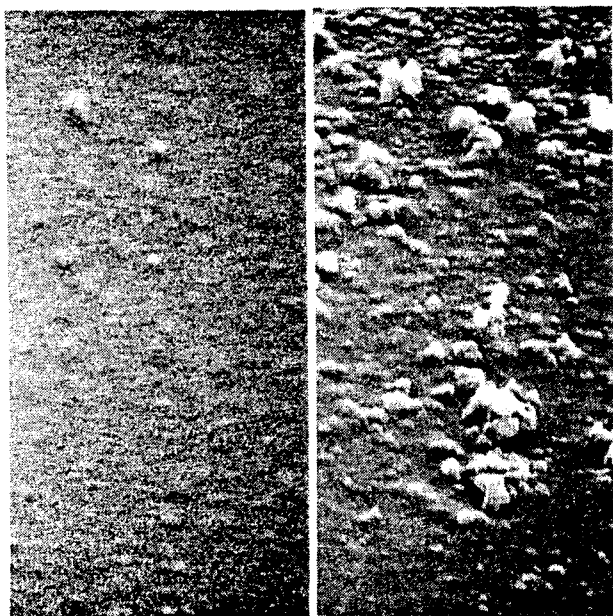
Scanning Electron Microscopy (SEM) was used to show insulator inner wall topography. Figure 3 shows a comparison of the surface of an unused insulator and one exposed to several switch closures. There is an obvious difference in the contamination level between the two insulators.

All the surface analyses results point toward deposition of metal electrode particles on the insulators. It cannot be directly proved that the metal particulate is the cause of electrical failure of the insulators. However, the extensive metalization found by the surface analyses will limit switch life and should be suppressed.

Fig. 3. SEM micrographs (10,000X) comparing surface contamination of unused plastic (left photo) with insulator exposed to ten switch closures.

Surface analyses comparison of used and unused insulators indicate a substantial plating of electrode material on the insulator. Two approaches are suggested for preventing the metal plating on the insulator: first, a change in the electrode material from brass to a tungsten-copper composite may substantially reduce this effect, second, the use of mechanical shields which do not allow a direct line of sight from the arc gap to the insulator. Designs incorporating both of these features are being readied for testing.
